IPX7 TEST REPORT

Sample Name : **Water Flosser**

Model Number : **WL2117,WL2117P**

TESTING LABORATORY : **Shenzhen Most Technology Service Co., Ltd.**

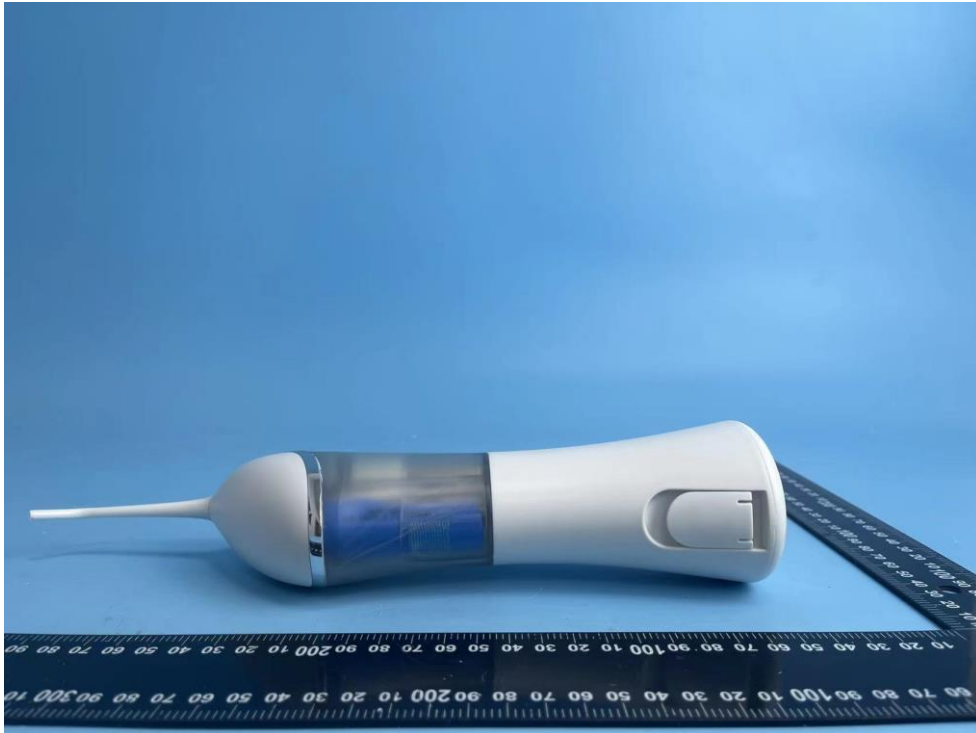
Photo1

Description: Overview of WL2117

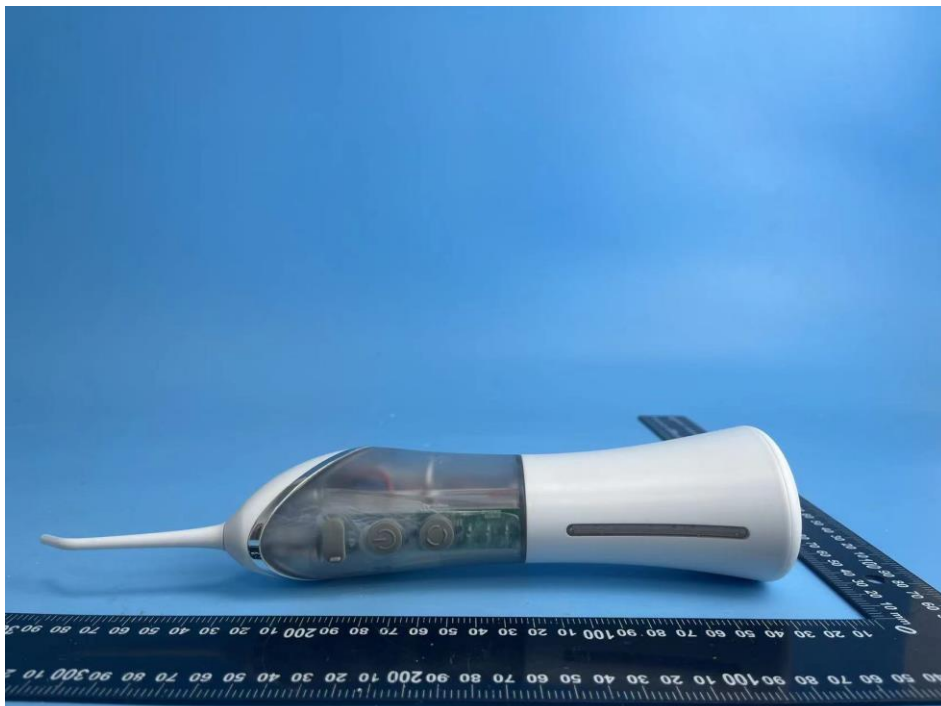
Photo2

Description: Overview of WL2117

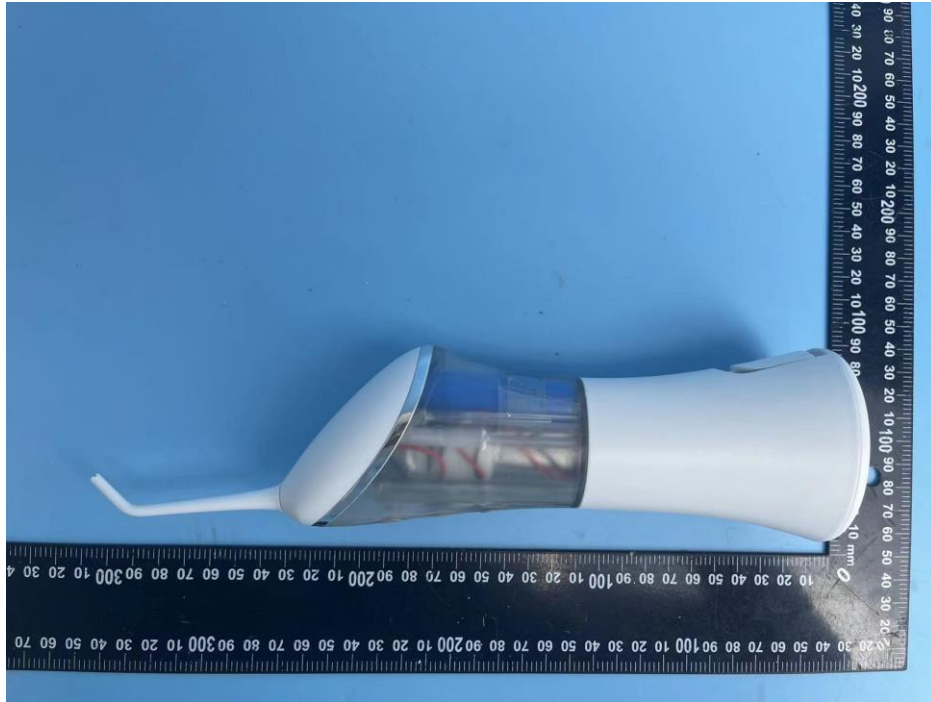
Photo3

Description: Overview of WL2117

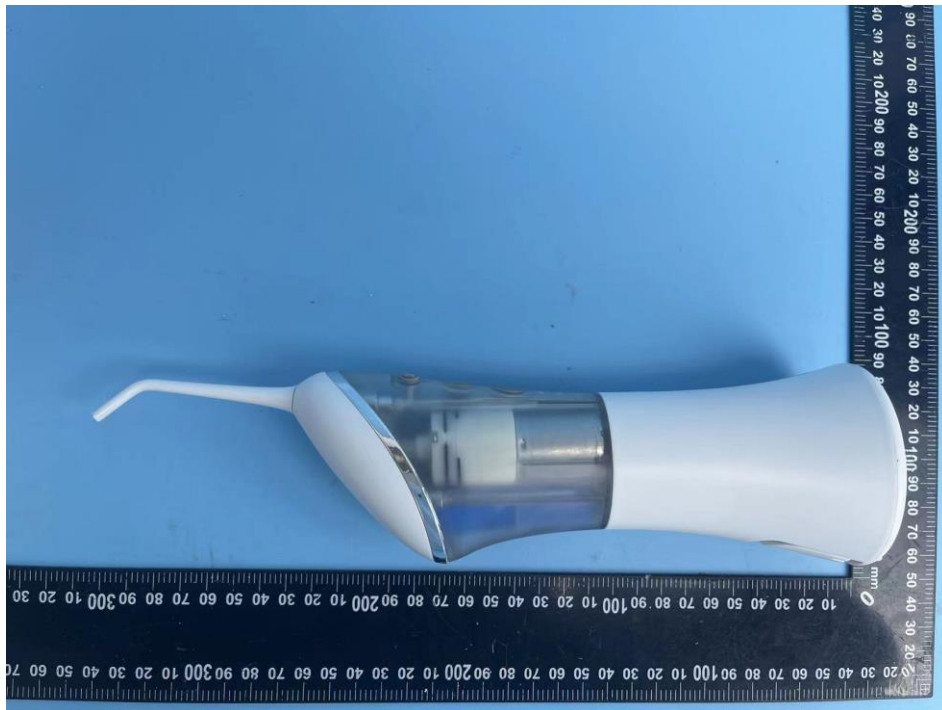
Photo4

Description: Overview of WL2117

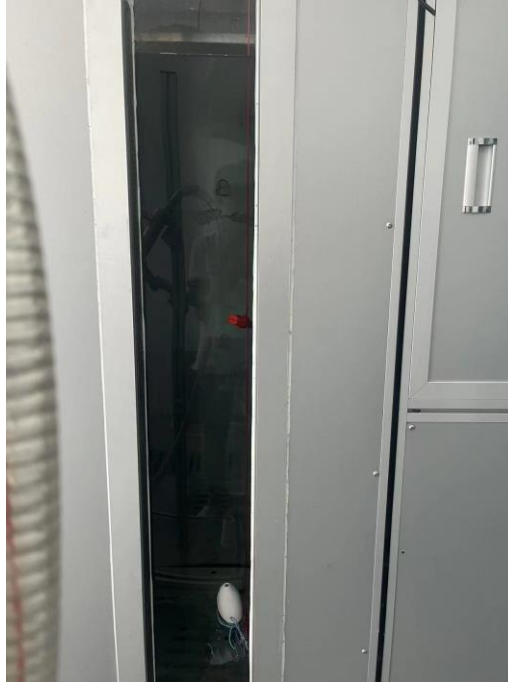
Photo5

Description: Test Photo

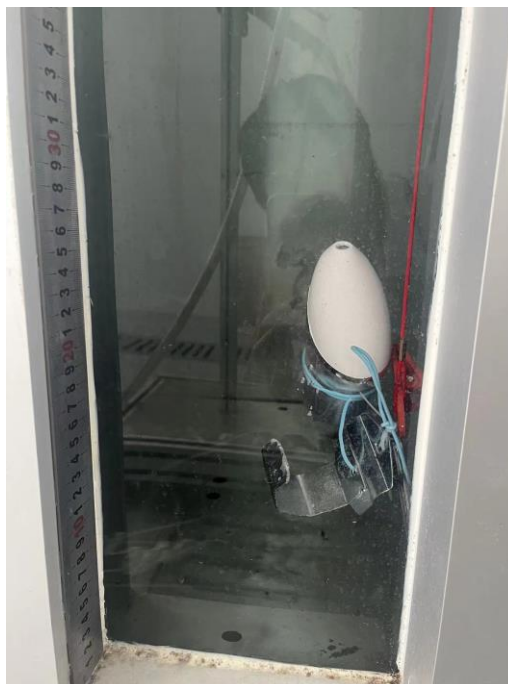
Photo6

Description: Test Photo

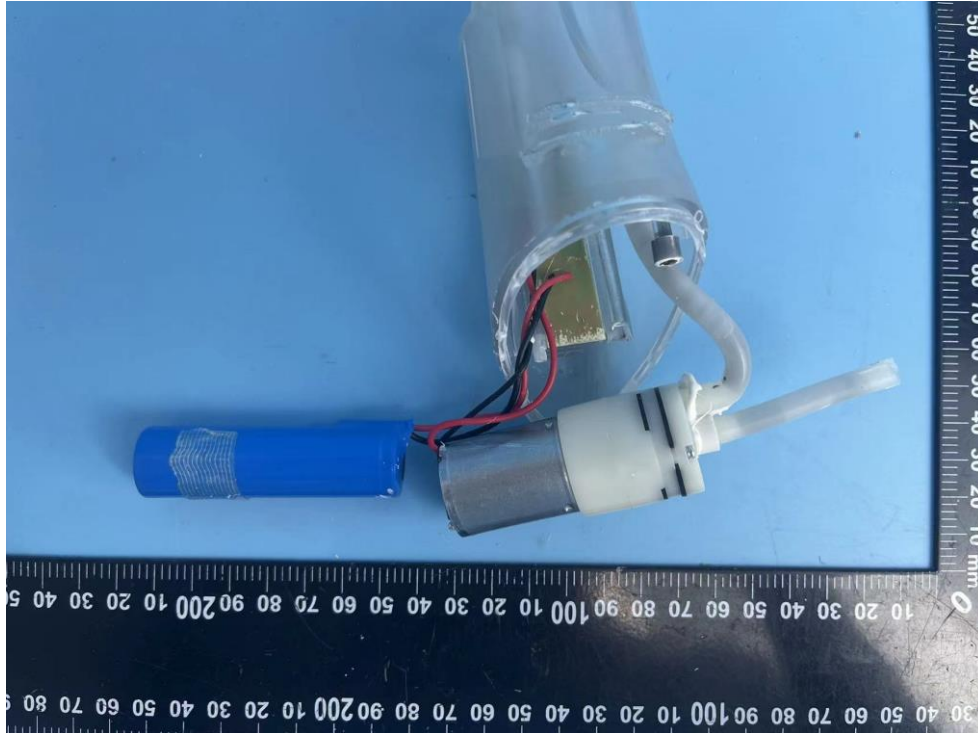
Photo7

Description: After testing of IPX7 WL2117s

Test result: There is no water inside, not affect the creepage distance and normally operation, the test is pass.

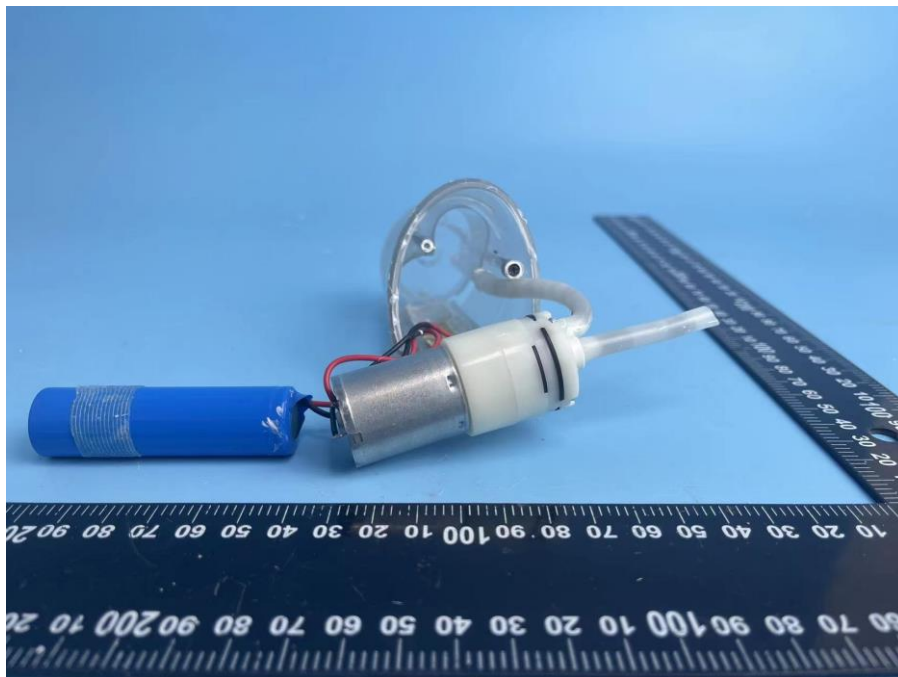
Photo8

Description: After testing of IPX7 WL2117

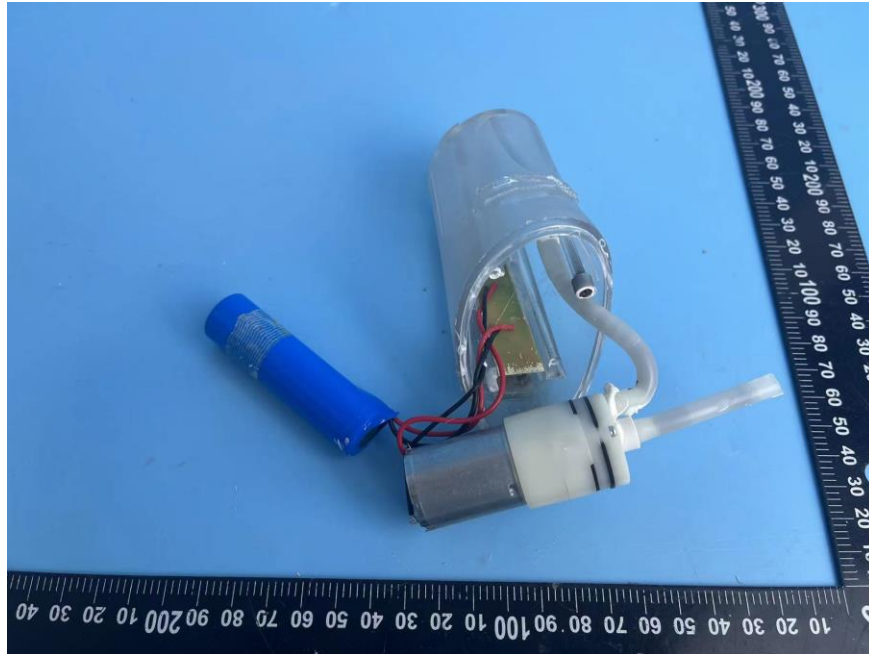
Photo9

Description: After testing of IPX7 WL2117
